# The Finishing Touch

Volume 8, Issue 2

## Featured Project The Gallery at Warren and Conner

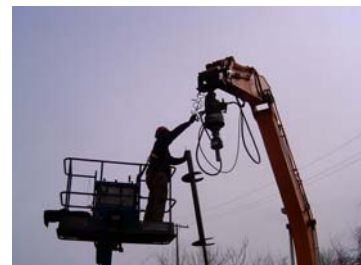
*Excavator installing a helical pier starter adjacent to an existing building.*

ATC and Associates contacted Kent Concrete Lifting to investigate the use of New Construction Helical Piers to support the proposed addition. (ATC was familiar with Kent Companies and had good things to say about the concrete division's excellent work at Gordon Foods in Green Oak Township). It was determined that helical piers were an excellent solution to the problem. Installation is vibration free and no spoils are created during installation, thus preventing the need to dispose of the contaminated soils at an environmental landfill. Installation equipment is small, allowing other trades to continue their respective work at the same time.

A total of 79 Chance-Atlas New Construction Piers were installed to depths of 30 feet in 5 working days. The total time from recognition of the problem to completed installation of the piers (to address and correct the problem) was less than 2 weeks. This included soils investigation, engineering review and design, fabrication of the specially designed helical starters, delivery and completed installation. The foundation contractor was installing pile caps and grade beams **immediately** behind the Kent Concrete Lifting crew.
